Polycoat Geotextile and Polyurea Delivers A Seamless Secondary Containment Solution for 100,000-Gallon Methanol Tanks In Alaska’s Prudhoe Bay

Project: Provide 37,000 sq. ft. secondary containment lining for BP’s 100,000-gallon methanol tanks in Prudhoe Bay, Alaska. Utilize 40,000 square feet of 8-mil geotextile fabric over the entire pit area and spray 80 55-gallon drums of Polyeuro® 5502 polyurea at 80-100 mils thickness creating a seamless ground protection barrier against the possibility of any methanol leaking from the tank.

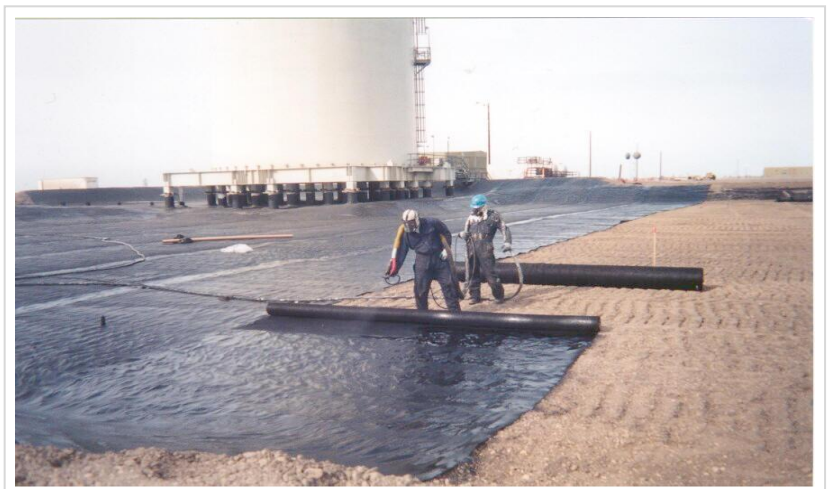
Polycoat Polyeuro® 5502 polyurea applied at 80-100 mils over 8-mil geotextile fabric sheets

To provide the monolithic membrane over the ground, a geotextile fabric was first laid out and then sprayed with Polyeuro® 5502 polyurea coating. The contractor used the Mirafi 180N Geo textile fabric which is a non woven Polypropylene fabric manufactured by Mirafi. A minimum of 80 mils (2mm) of polyurea coating was sprayed over the fabric resulting in a puncture proof seamless membrane.

Laying the fabric took several hours. While the fabric was being laid in place, another contractor pre-heated the polyurea to ready it for application in the fringed environment. The Polyeuro® 5502 polyurea spray process took several passes to give them the specified 80-100 mil layer, about half of which penetrated into the base of the geotextile fabric layer.

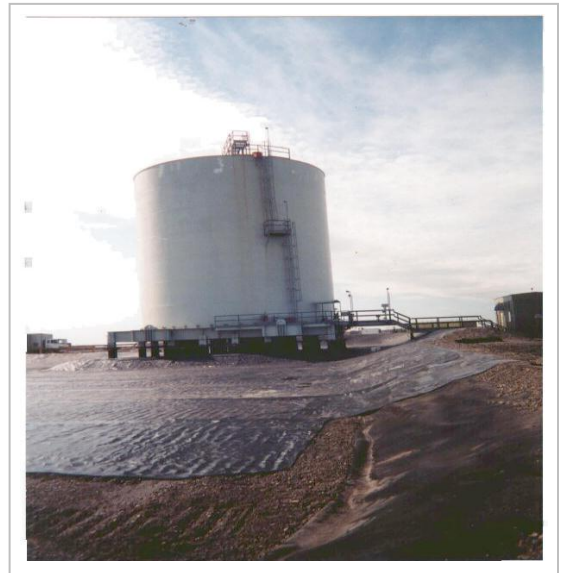
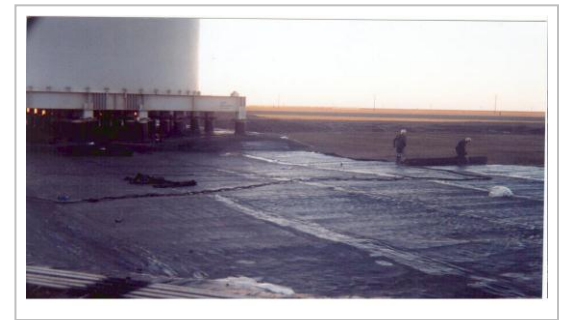
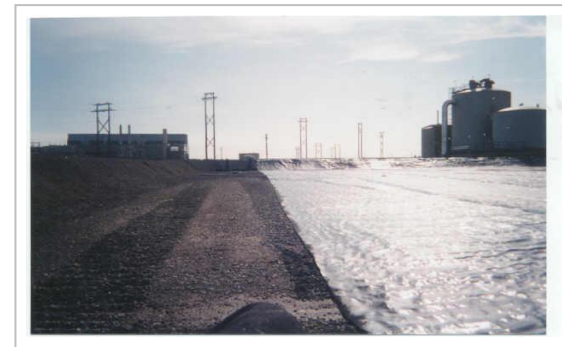
The contractor also provided some expansion loops to address the problem of contraction associated with polyurea systems. The ends of the fabric were mechanically anchored in the ground at the Berms by making 2-3 feet trench and back fill with the dirt. Around the tank pillars the fabric was overlapped and firmly sealed with the Polyeuro® 5502.

After almost 12 years, the Polycoat geotextile / Polyeuro® 5502 polyurea system is still delivering its protective secondary containment barrier solution for British Petroleum's 100,000 gallon methanol tanks In Prudhoe Bay, Alaska.

After the pits were vacuumed, the crew unrolled the 18 ft. sheets of geotextile fabric, taking care to overlap each of the seams and cover the base of the pilings that support the tank. To contain any possible leak, the fabric had to be carried up the sides of the berm, and its edges firmly secured with a 2 ft.-wide, 2 ft.-deep trench that would be covered with gravel.
